H.M.A.S. "SHEPPARTON"
GENERAL ARRANGEMENT
[AS FITTED]
LOWER DECK & HOLD

H.M.A.S. "SHEPPARTON"

SURVEY & CHART ROOM - AFT SUPERSTRUCTURE X

CONSTRUCTION DETAILS

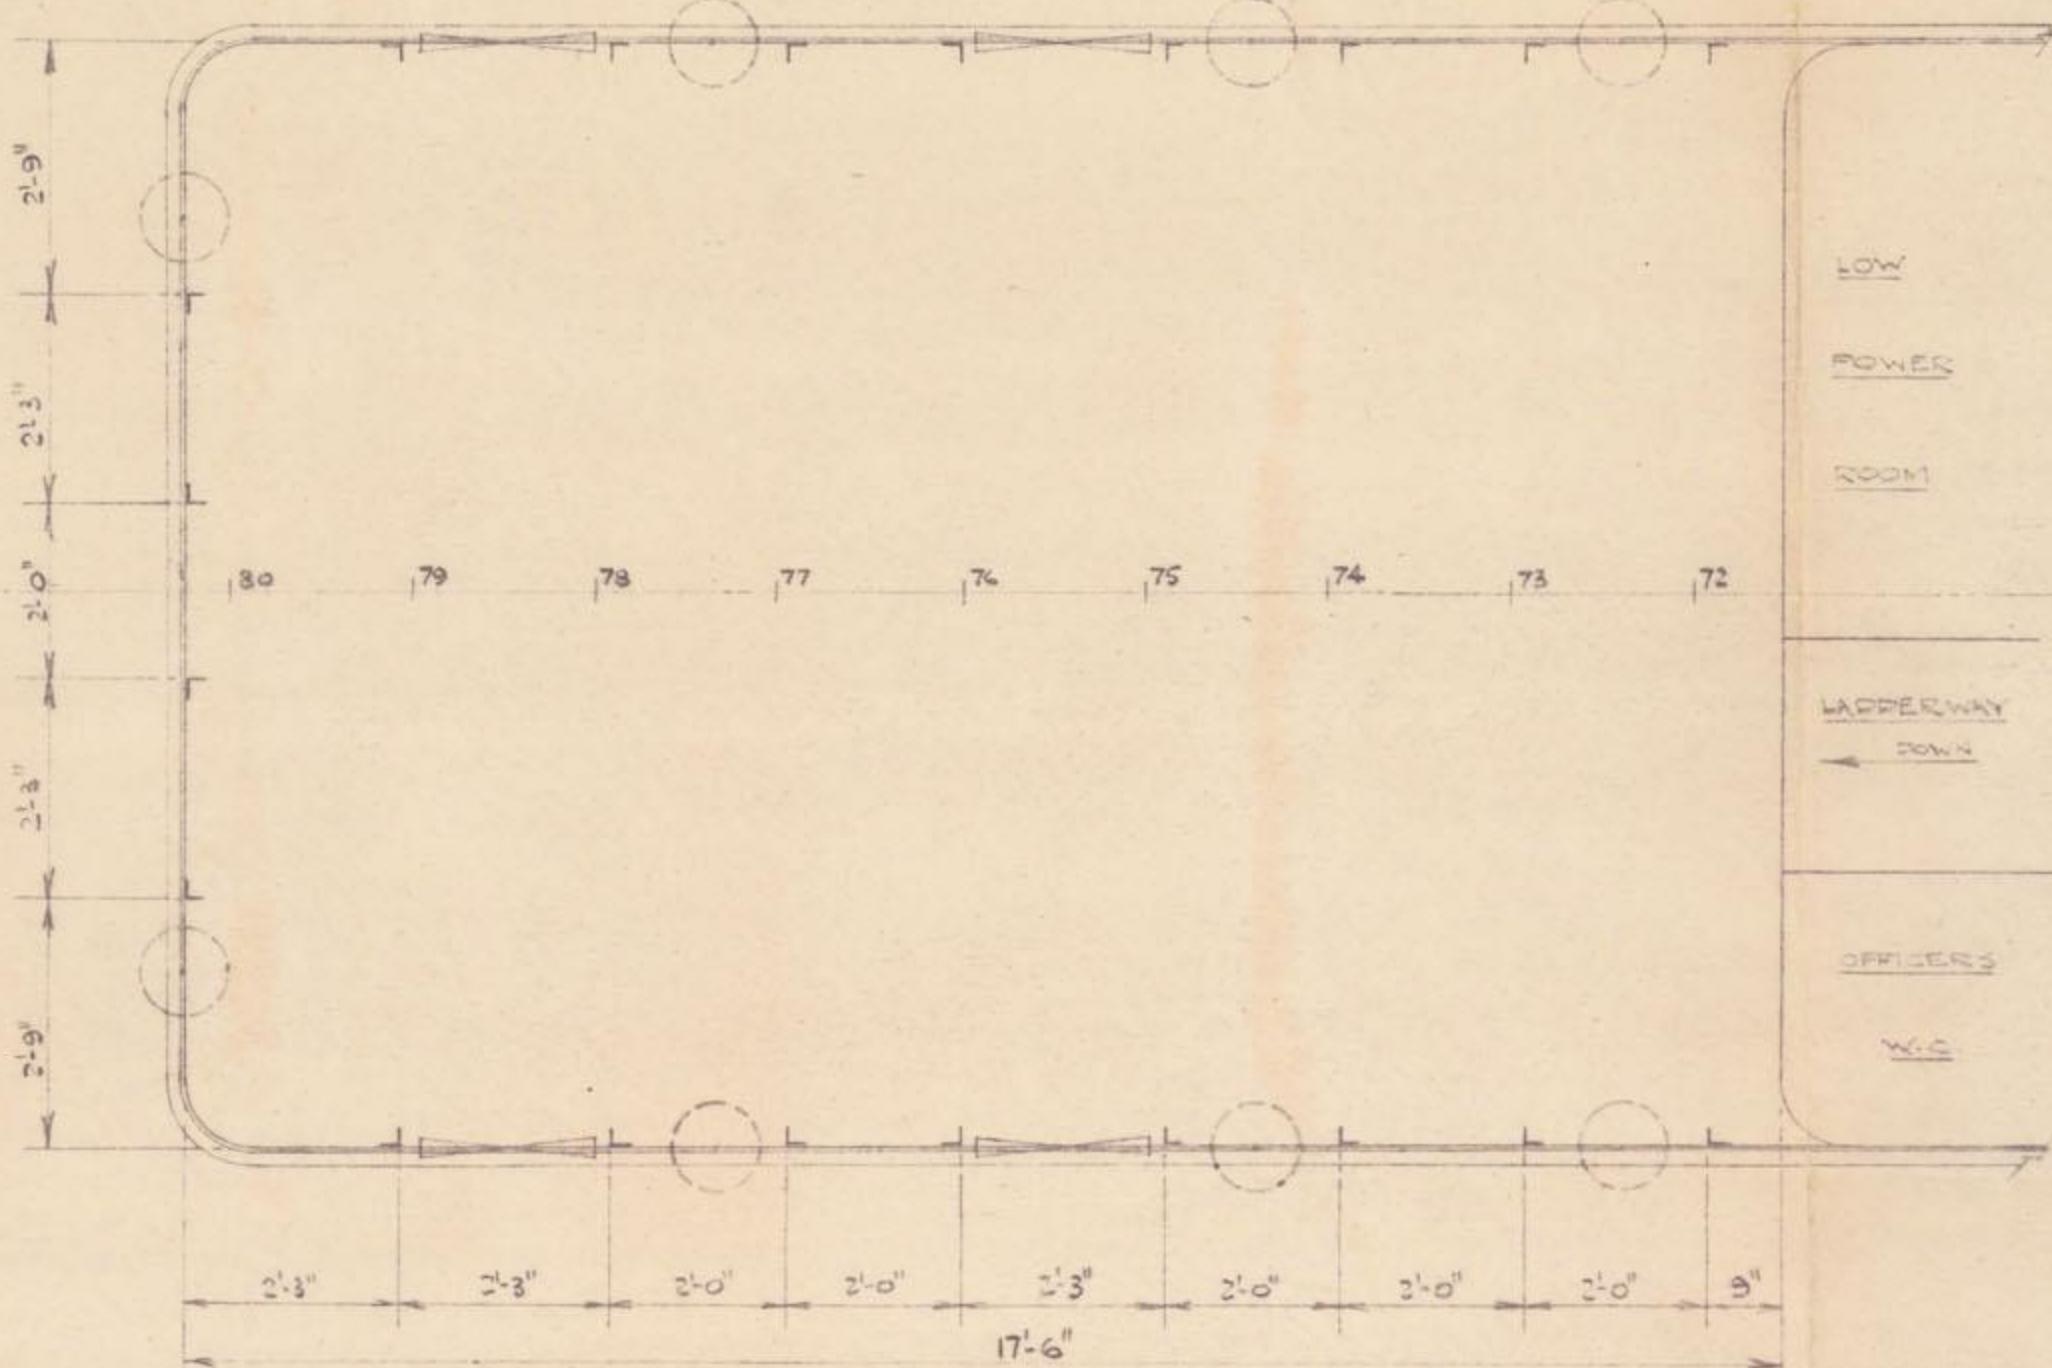
PLAN AT UPPER DK.

False decking removed.

EXTRACT FROM S.M.A.G.I'S LETTER DATED 26/11/53

"The old weather deck timber has been completely removed, including the boundary angle. New coamings and boundary angles were fitted to the deck house to prevent a recurrence of the corrosion. The deck plating has been cleaned and covered with coatings."

FILE 4284/29/53, "Report of Survey of Hull Structure" refers.

See also GMG.I Letter 2339

16/3/54. (4284-29-40) which officially confirms the above alteration
